Comparative assessment of Airflex[®] insulation in roofs

**Report No. CIM 151/r1
July 2006**

Centre for Infrastructure Management

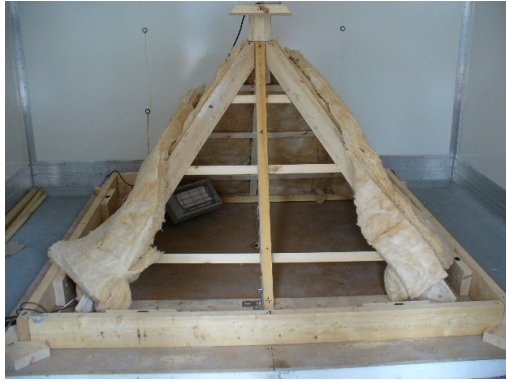
The insulation materials were applied in accordance with standard procedures. Referring to Fig. 2, 100mm thick Glasswool was placed between rafters (approx. 100 x 46mm cross-section) with a further 100mm layer placed at right angles over the top of the rafters. A 25mm air gap was maintained between the insulation and the external MDF boards. The same roof was used to monitor the performance of Airflex as shown in Fig 3 with the Airflex insulation wrapped over the outer surface of the rafters. Two types of jointing techniques were used in accordance with the

Fig. 2 Glasswool applied between rafters

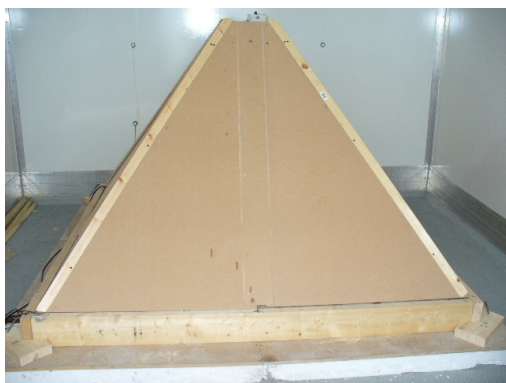
Fig. 6 Finished enclosure under test

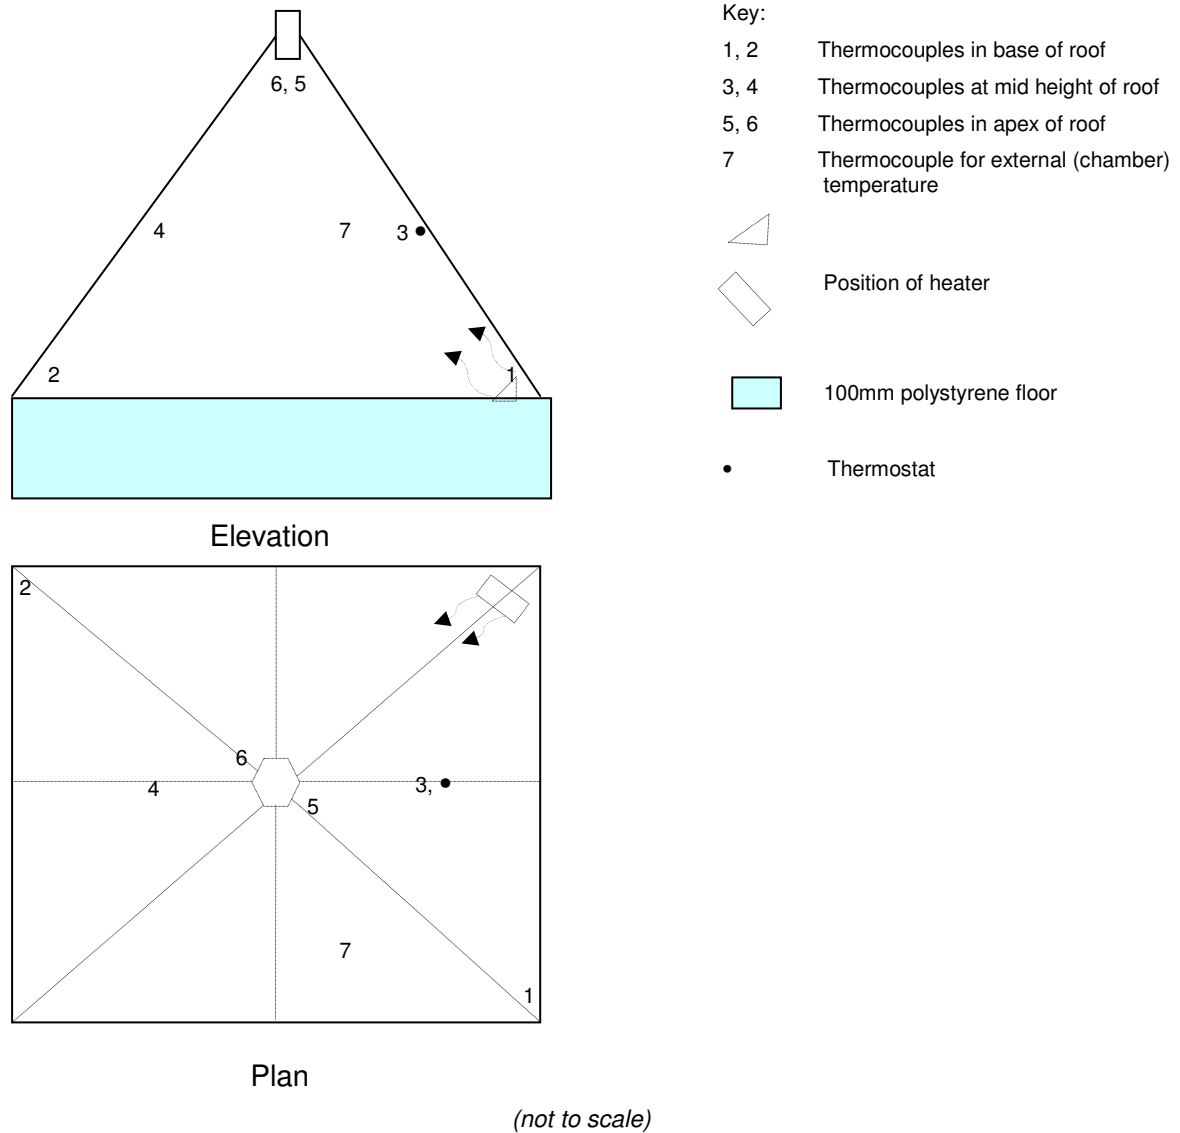
A total of seven thermocouples (type T) were employed to measure the internal and external temperatures. All thermocouples were calibrated in the laboratory before application and a calibration factor, where necessary, was applied to the data. The approximate locations of the thermocouples are shown in Fig. 7. Two thermocouples were placed internally in the base of the roof (labelled 1 and 2), a further two thermocouples were placed internally on the rafters at mid height (labelled 3 and 4) and two were located internally in the apex of the roof (labelled 5 and 6) as shown in Figure 7. The external temperature was monitored by a thermocouple positioned at mid-height in the centre of one face of the roof (labelled 7, Fig. 7).

Fig. 7 Location of thermocouples, thermostat and heaters

The enclosure was provided with a Hotspot Ceramic Heater (model HSE 1500, Fig. 7). This is a 1.5kW radiant heat source with dimensions of 340 x 210x x 210 mm. The heater had a set point of 21°C and was controlled by a thermostat attached internally to the central rafter as shown in Fig. 8.

The profiles from the internal gauges in Figs. 11-13 are predominantly horizontal indicating that a steady state is reached. It is clear, however, that the temperature profiles in the Airflex insulated roof are closer together indicating a lower temperature variation between the floor and apex of the roof as opposed to the Glass wool insulated roof (the reflective material is more efficient in circulating heat within the enclosure). In addition, the profile of thermocouples 'Internal (3, 4)' in all tests unsurprisingly exhibits a temperature close to 21°C as the thermocouples are at a similar height in relation to the heater thermostat (Fig. 7).

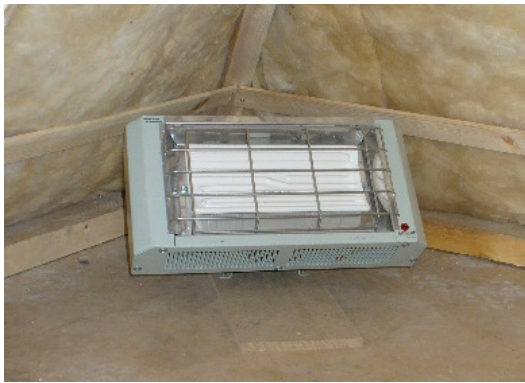
Fig. 8 Ceramic heater in position

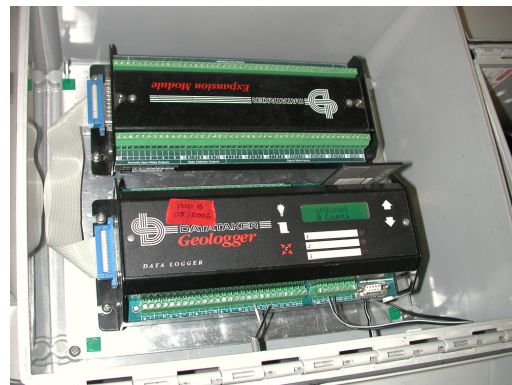
The data logging equipment is shown in Figs. 9 and 10. The power consumption by the heater was monitored by a single phase residential meter (Fig. 9) and the cumulative usage in kWh was recorded. The temperature at the thermocouples (Fig. 6) was monitored at 10 minute intervals by an automatic logging device (Datataker DT615 and a channel expansion module) as shown in Fig. 10. Stored data was downloaded at the end of each test (approximately every two days) for analysis.

Fig. 10 Data logger (lower) and channel expansion module (top)

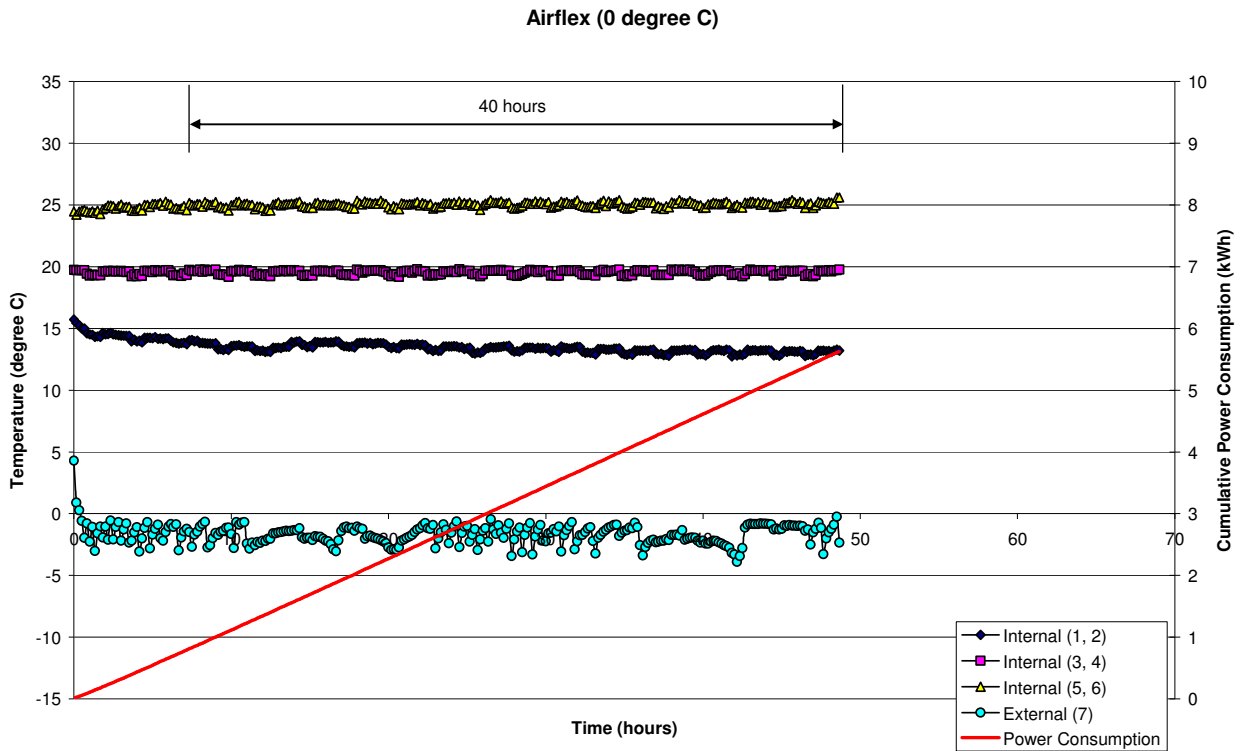
Figs. 11-13 show the recorded temperature profiles and power consumed within the monitoring period which enables a comparison of performance between Airflex and Glasswool as insulation materials when tested as described in Section 4. The data is presented over a period of up to 70 hours but the analysis concentrates only on the steady state data (the last 40 hours of monitoring). Therefore, the early age data is ignored as this will include the influence of changeover of test increment where the climatic chamber is either heating up or cooling down to reach the desired target temperature. Referring to Figs. 11-13, four temperature profiles are presented in the graphs. Internal (1, 2), (3, 4) and (5, 6) refers to the average of the two thermocouples at locations 1 & 2, 3 & 4 and 5 & 6 respectively (Figure 7). However, thermocouple 2 in Figs. 11 and 12 malfunctioned during the +5 and 0 degree tests hence the temperature for thermocouple 1 only is used in these figures. External (7) refers to the external temperature recorded from thermocouple 7 (Fig. 7). External (7) in the relevant figures represents the target external temperature of -5°C (Fig. 11), 0°C (Fig. 12) and +5°C (Fig. 13). The heater inside the roof space had a set point of 21°C as described in Section 4.3. Analysis of the data presented in Figs. 11-13 is presented in Section 5.2.

Fig. 12 Temperature profiles at 0°C

Referring to Figs. 11-13, a similar trend is evident in all profiles. In the early stages of testing, the external temperature in the environmental chamber is allowed to stabilise. The heaters are then switched on in the enclosure. The power consumption steadily increases as energy input is required to maintain a target temperature of 21°C.

Col. 1 shows the materials under consideration and col. 2 gives the target external temperatures of -5°C, 0°C and +5°C. The actual average external temperatures over the 40 hour monitoring period are given in col. 3 (taken from 'External (7)', Figs. 11-13), and the average internal temperature is shown in col. 4. Since the temperature within the respective roof increases from the base to the apex as shown in Figs. 11-13, the internal average temperature is obtained through a process of integration to account for the variation in increasing temperature and decreasing volume along the height of the roof. Col. 4 also shows that the Airflex insulated roof maintained a higher average internal temperature at each of the target internal temperatures of -5°C, 0°C and +5°C. Col. 5 gives the internal and external temperature gradient (col. 4 - col. 3). The power consumed within the 40 hour analysis period is given in cols. 6 and 7 respectively for each test (from 'Power Consumption' in Figs. 11-13) and the total power consumed in kW over this 40 hour period is given in col. 8 (col. 7 - col. 6). The power consumed in col. 8 is converted to kJ in col. 9 (col. 8 x 3.6 e10⁶). A constant density of 1.204 kg/m³ is assumed for the air inside the enclosure (col. 10) and the volume of airspace is estimated in col. 11 (the thicker Glasswool insulation leads to a reduction in the volume of air inside the enclosure). The resulting mass of air in the enclosure is shown in col. 12. The apparent specific heat, c , required to maintain the target temperature of 21°C inside the enclosure is given in col. 13 and is calculated from Equation 1. The percentage difference in specific heat is shown in col. 14 and indicates that the performance of the Airflex insulation material is 44.5%, 40.1% and 43.7% more efficient than the Glasswool when tested at -5°C, 0°C and +5°C external temperature respectively.

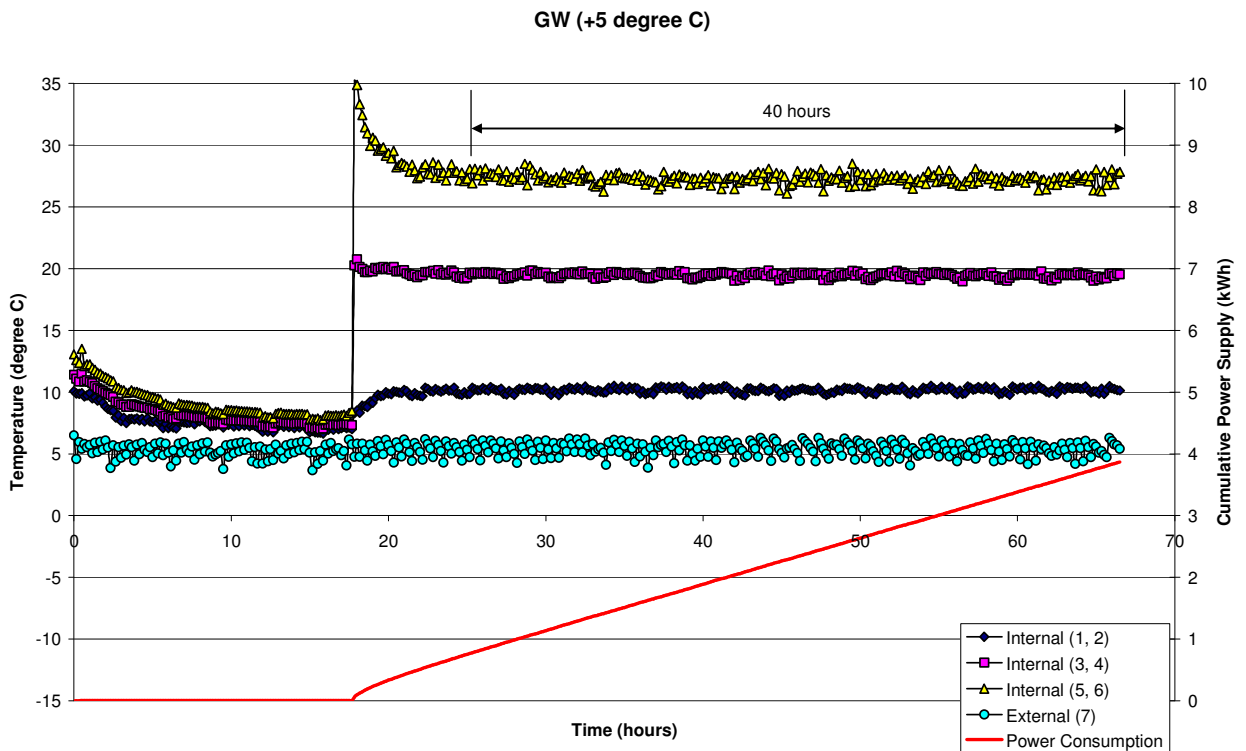
Fig. 13 Temperature profiles at +5°C
